## AMERICANS WITH DISABILITIES ACT

City of Garland
Compliance Transition Plan:
Programs/Services Accessibility

# ADA - COMPLIANCE TRANSITION PLAN: PROGRAMS/SERVICES ACCESSIBILITY

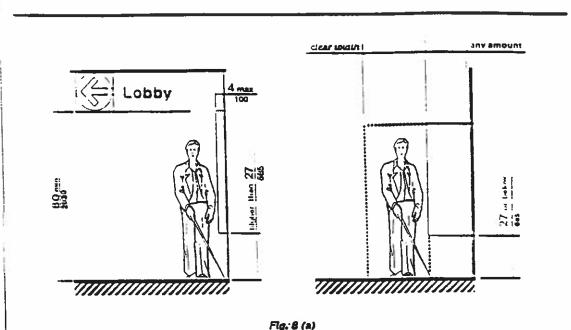
Fig. 8
Protruding Objects

Fig. 8 (a) Walking Parailei to a Wall

Fig. 8 (b) Walking Perpendicular to a Wall

finished floor (see Fig. 8(c), and (d)). Protruding objects shall not reduce the clear width of an accessible route or maneuvering space (see Fig. 8(c)).

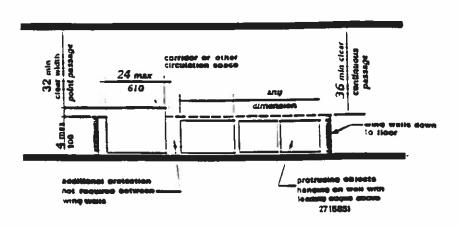
Fig. 8
Protruding Objects (Continued)

Fig. 8 (e)
Example of Protection around Wall-Mounted Objects and Measurements of Clear Widths

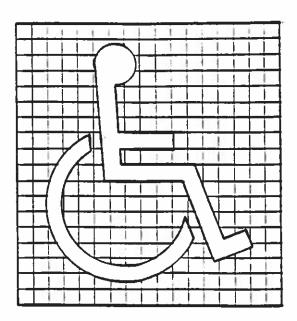
Fig. 43
International Symbol of Accessibility

(a) Proportions

(b) Display Conditions

4.28.5 Symbols of Accessibility. If accessible facilities are identified, then the international symbol of accessibility shall be used. The symbol shall be displayed as shown in Fig. 43.
